Manhole Inspection Summary

Manhole # S51K__015MH

Insp Date: **4/1/08 10:05 AM**

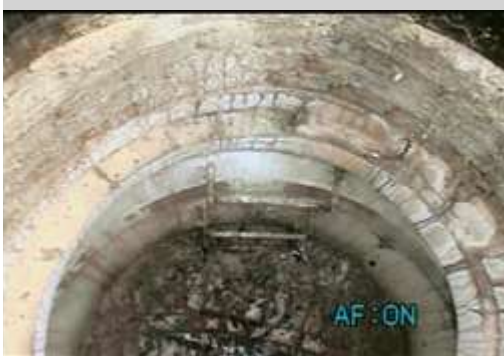
Defect 1

Steps Count: **3** Missing: **0** ☒ **Corroded**

steps

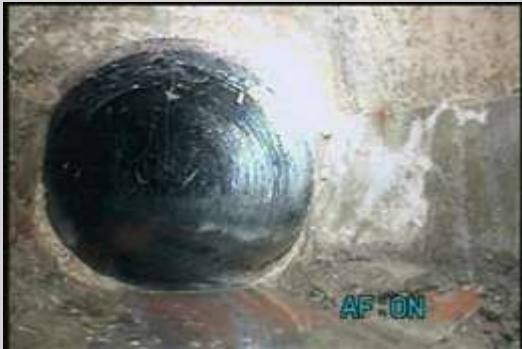
12 O'Clock Outflow

8 in. Circular Gravity Sewer
Pipe Out @ 12 O'Clock

Pipe Material: **Unknown** ☐ Pipe Lined

Invert Depth: 7.00 (ft.) Flow Characteristics: **Slow**

Infiltration: **None** Pipe Seal Cond: **Unknown**

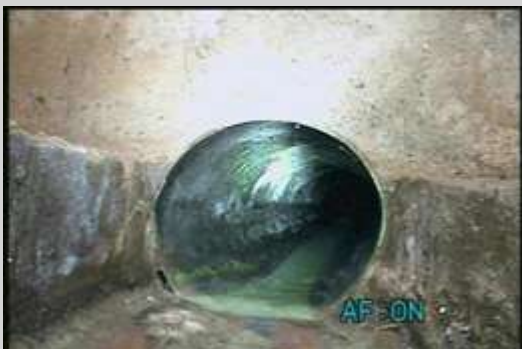
7 O'Clock Inflow

8 in. Circular Gravity Sewer
Pipe In @ 7 O'Clock

Pipe Material: **PVC** ☐ Pipe Lined

Invert Depth: 7.00 (ft.) Flow Characteristics: **Slow**

Infiltration: **None** Pipe Seal Cond: **Unknown**
